ENVIRONMENTAL PROBLEMS RELATED TO POOR STORM WATER CONTROL ON THE UNPLANNED HILLSIDE BUILT ENVIRONMENT OF BOTSWANA - IN THE CASE OF PELENG, LOBATSE -

Thabiso Seno ¹, Nobuyuki Ogura ²

Department of Civil Engineering and Architecture

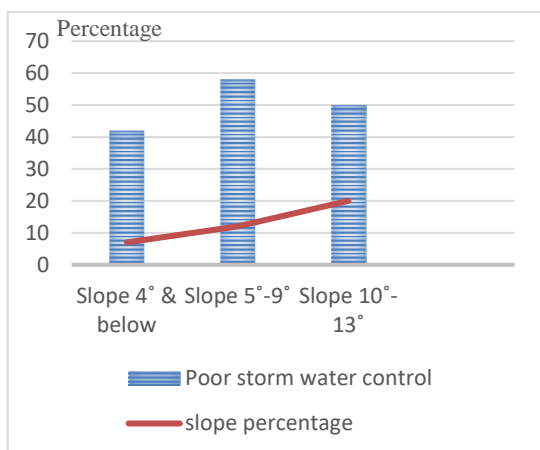
Fig.3. Record of Poor Storm Water Control

Residents of Peleng reported many problems that are caused by uncontrolled storm water runoff. The improper control of storm water runoff can be defined as poor storm water control. Among the problems mentioned by residents is that there is too much storm water runoffs into their plots and that this water comes with waste and stones, accumulates around the house, exposes pipes and rocks, take trees down, removes vegetation and soil, and also damages the buildings. The problems were then categorized and analyzed. Fig.3 shows that poor storm water control situation is worse on slope 5°-9° category.

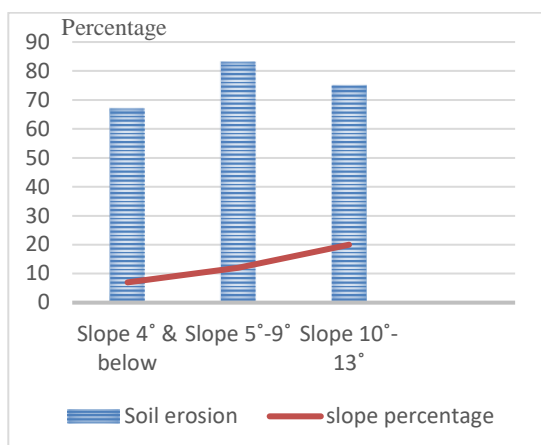
Fig.4. Record of Soil erosion

Erosion occurs when soil is left exposed to rain or wind energy, raindrops hit exposed soil with great energy and easily dislodge the soil particles from the surface (Pimentel, 2006). In the hillside it's worse because the loose particles are immediately washed away by flowing water due to gravity. Accelerated soil erosion by water is about 56% and wind erosion is responsible for about 28% (Agyarko et al, 2012). Fig.4 shows that erosion is higher in slope 5°-9° than in slope 10°-13° category. This is because the upper hillside has a retaining wall to minimize the flow of water.

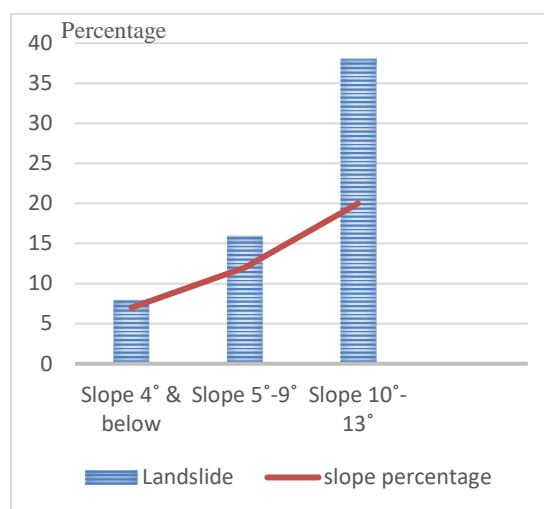
Fig.6. Percentage landslide reports per each slope category

Landslides are not too common in Peleng as it's a rocky hillside but a few were reported by the residents. Majority of the residents reported that the rocks were coming from above the hill and sometimes destroying their houses. Other residents reported that due to landslides their boundary walls collapsed because there are no retaining walls as in Fig.7. Fig.6 indicates that the upper slope experienced more landslides because of its steepness and rocky topography.

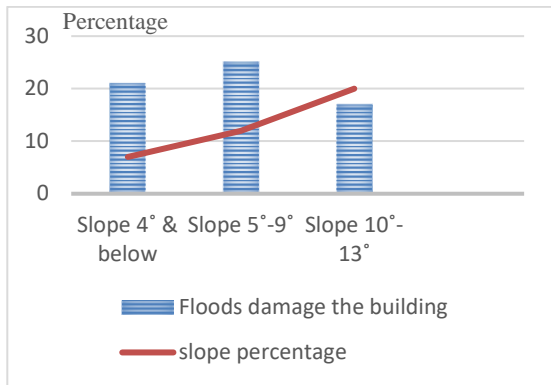
Fig.8. floods damage on buildings reports per each slope category

Residents reported that storm water runoffs from the top had exposed the base of their buildings, hence making their building weak and allowing water to enter inside their houses. Fig.8 indicates that floods damaged the building more in slope 5° -9° and slope 4° & below. Slope 10°-13° reported less damage of buildings by floods because there was a retaining wall and most of the foundation were built on top of the rocks.

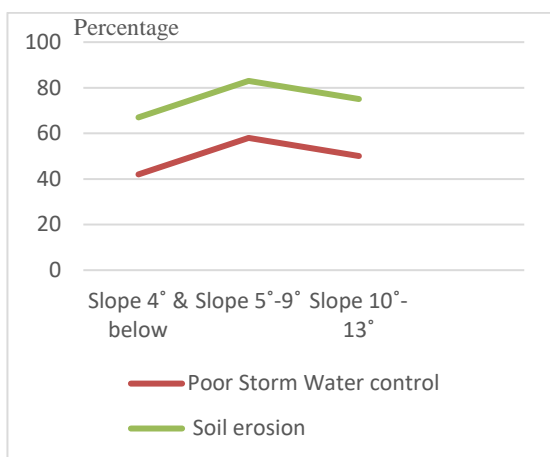
Fig.10. Percentage of Poor storm water control per each slope category in relation to soil erosion

Analysis from fig.10 suggest that where there was poor storm water control, there was also high record of soil erosion. These is because the poor storm water control line is parallel to the soil erosion line. Slope 10°–13° degrees situation is better because of the water retaining wall that has been placed on the hillside just above this slope category.

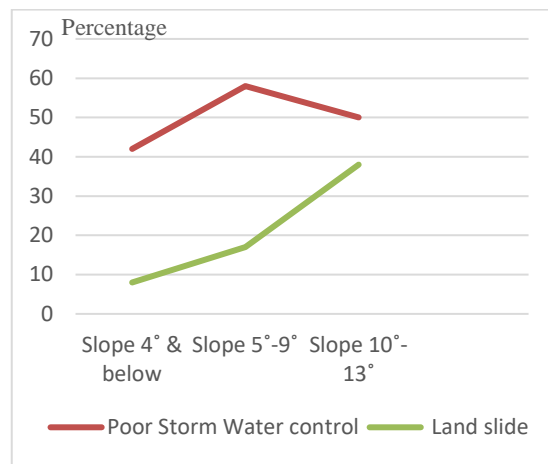
Fig.11. Percentage of Poor storm water control per each slope category in relation to soil erosion

The analyses from fig.11 indicates that poor storm water control and landslide lines of slope 4° & below and slope 5° – 9° are parallel to each other until they reach slope 10°-13° where now the poor storm water control line goes down and the landslide line goes up. It can be derived from fig.11 that landslide situation is worse on the upper part of the hillside even though percentage of poor storm water control is low. This mean that there are many loose rocks on the upper side of the hill than on the built up area and their effect is felt more by the residents on the upper slope. Since the water retaining wall on the upper slope is too low, it is unable to block the rocks coming from the top of the hill.

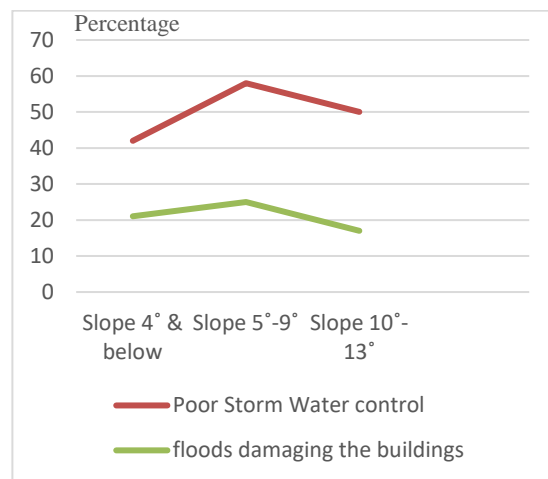
Fig.12. Percentage of Poor storm water control per each slope category in relation to soil erosion

Fig.12 indicates that there is higher percentage record of poor storm water drainage recorded as there is for floods damaging the building in slope 5°-9°. This relation indicates that when there is poor storm water control then floods damages the building. Fig.12 also indicates that water retaining wall on top of the hill has contributions in reducing the impacts of damage on the buildings as seen for slope 10°-13°.
