ANALYSIS OF THE PIT LATRINE TOILETS SITUATION AND THEIR EFFECTS ON LOW INCOME RESIDENTIAL OF THE HILLSIDE BUILT ENVIRONMENT IN BOTSWANA - IN THE CASE OF PELENG, LOBATSE -

Thabiso Seno¹, Nobuyuki Ogura²

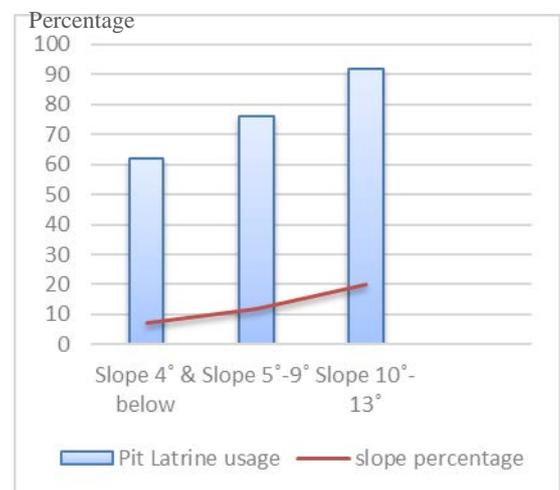
Fig.4. Percentage of Pit Latrines used per each slope category

Fig.4 indicates that the percentage number of people using pit latrines is low on the lower slope and increase gradually with the higher slope. It is linked to the fact that it is easy for residents on the lower slope to connect to sewer lines hence difficult for residents on the upper slope.

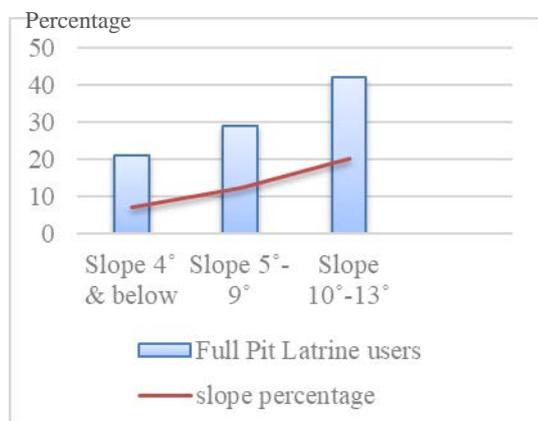
Fig.5. Percentage of Full Pit latrines per each slope category

to pay for the sewer truck to come and empty the pit latrines. Others linked the problem to the fact that sewer trucks cannot access their plots to empty their pit latrine toilets (Seno, Lyamuya and Ogura). Fig.4 shows the percentage of residents that reported full pit latrine toilets.

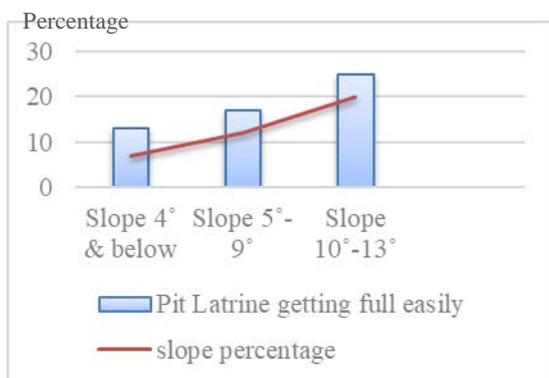
Fig.6. Percentage of litter not regularly collected per each slope category

Due to rocky conditions of the hillside especially the upper part, it is difficult if not impossible to dig a deep hole for pit latrines toilets as per the report by residents. This contribute to pit latrines getting full easily. Another reason reported by residents causing pit latrines to get full easily is that there are many people residing in one plot, hence each plot only has one pit latrine toilet. Fig.6 indicates that pit latrines get full easily on the upper part of the hill which is related to the difficulty in digging deep for pit latrines pit.

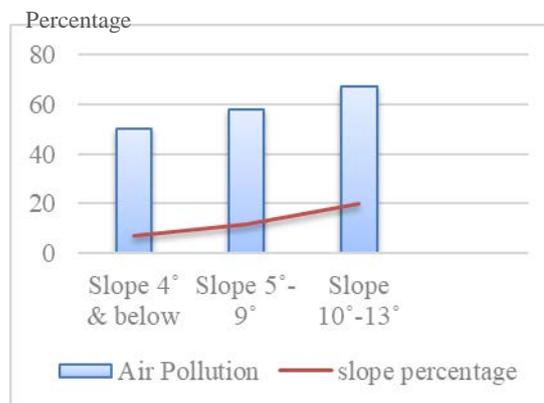
Fig.6. Percentage of litter not regularly collected

Residents reported that their toilets were causing bad odors on the living environment because they were either full or they got full easily. Fig.7 indicates 40% reports of air pollution distributed per each slope category.
