# ANALYSIS AND IMPACTS OF HILLSIDES DEVELOPMENTS NOT REGULATED BY BUILDING PROFESSIONALS IN THE LOW INCOME AREAS OF BOTSWANA - IN THE CASE OF PELENG, LOBATSE -

Thabiso Seno<sup>1</sup>, Nobuyuki Ogura<sup>2</sup>

Department of Civil Engineering and Architecture

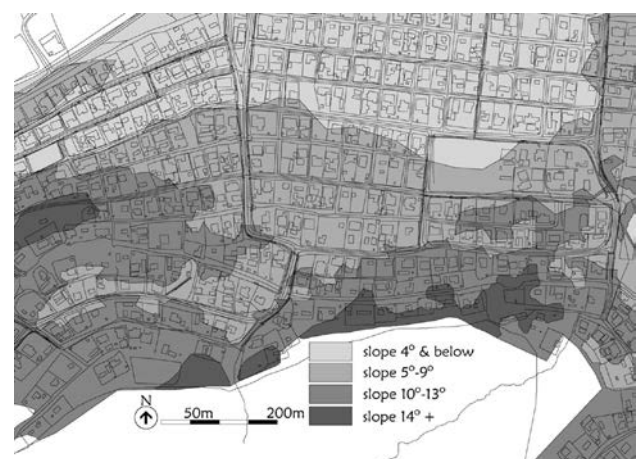
Fig.2. Map showing different slope categories

of the hillside. Then Dynamo Visual Programming was used to determine different slope categories. Map with plots and footprints of houses was then superimposed on top of the slope map to identify plots per each slope category and presented as in Fig.2.

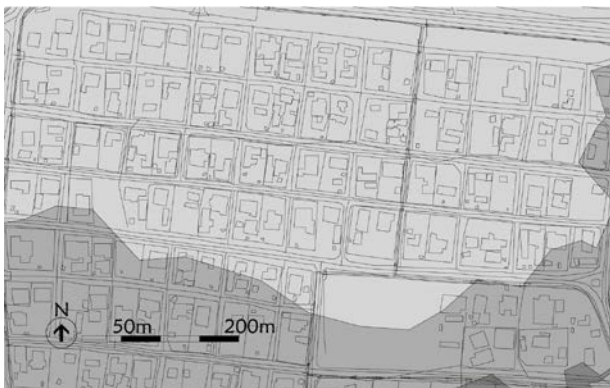
Fig.3. Images showing plots stack next to each other

Through the interview the elderly residents mentioned that the time when they started allocating themselves plots Lobatse chief advised them to settle in a linear form. The chief's advice was that if they do not allocate themselves plots in a linear pattern then in future when the government wants develop the neighborhood their structures will be demolished (Seno, Lyamuya and Ogura, 2018). The residents then started choosing their plots next to each other in random sizes and irregular shapes as in Fig.3.

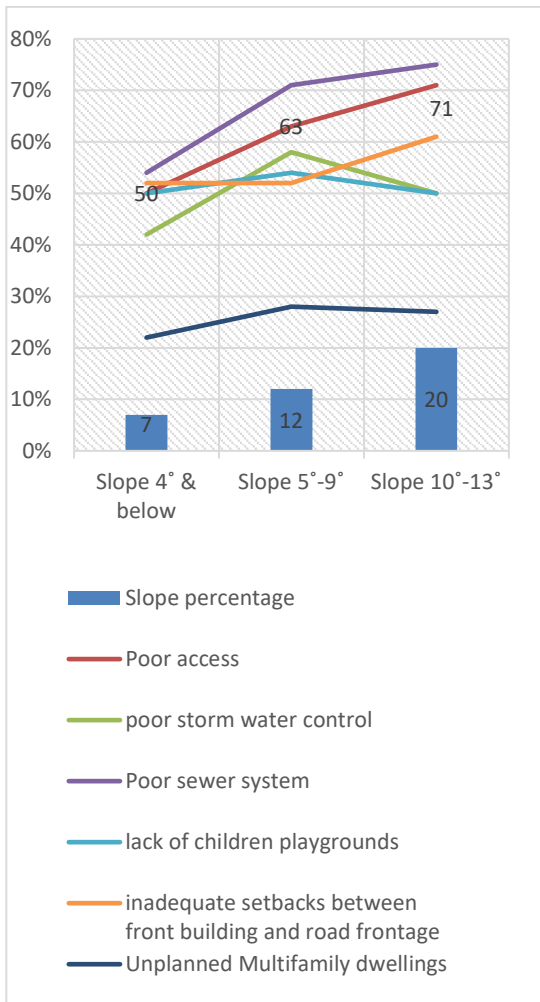
Fig.8. Analysis of developments not regulated by Urban Planners

The initiative of allocation of land in Peleng through just aligning plots have resulted in lack of land use zoning. According to DCC land use zoning is defined as the grouping of homogeneous and mutually supporting family of land use activities in an area (MLH, 2013). This have led to some residential plots operating as bars or shops whilst sharing plot boundary with residential dwellings as in Fig.10. These compromises privacy and security for neighbors. Inadequate open spaces for children play areas is also a resultant of lack of proper planning as indicated in fig.9. Fig.8 shows that slope 5°-9° had higher lack of play areas, likely because there are

open spaces on the upper hill because it's undeveloped in slope 14° & above, and there are community grounds on the lower hill near Peleng. Fig.8 shows other problems associated with the due impact of developing without urban planners such as unplanned multifamily dwellings, inadequate setbacks, poor access, poor sewer system and poor storm water control as in Seno and Ogura (2018).

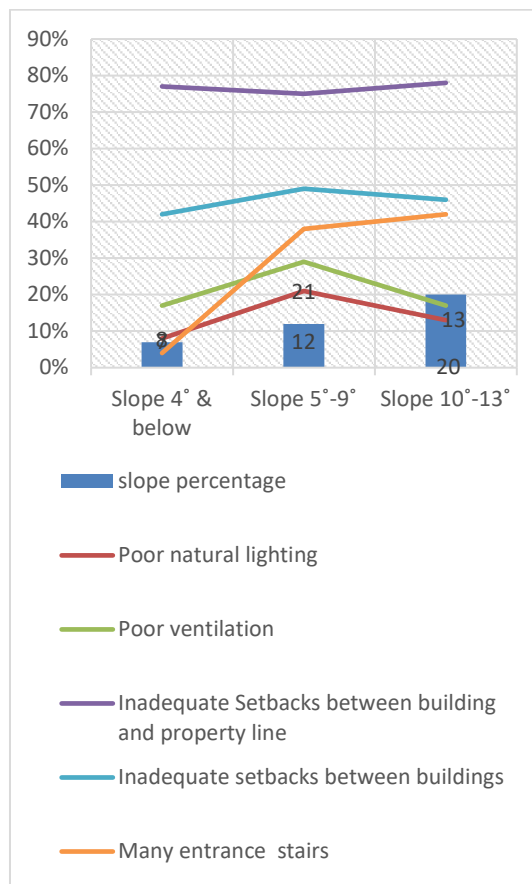
Fig.11. Analysis of developments not regulated by Architects

The analyses from Fig.10 indicates that houses with many entrance stairs increases as the slope gets steeper hence the highest record of many entrance stairs was recorded at slope 10°-13°. Many stairs at the entrance make it difficult for elders and the disable to enter the house making it not user friendly.

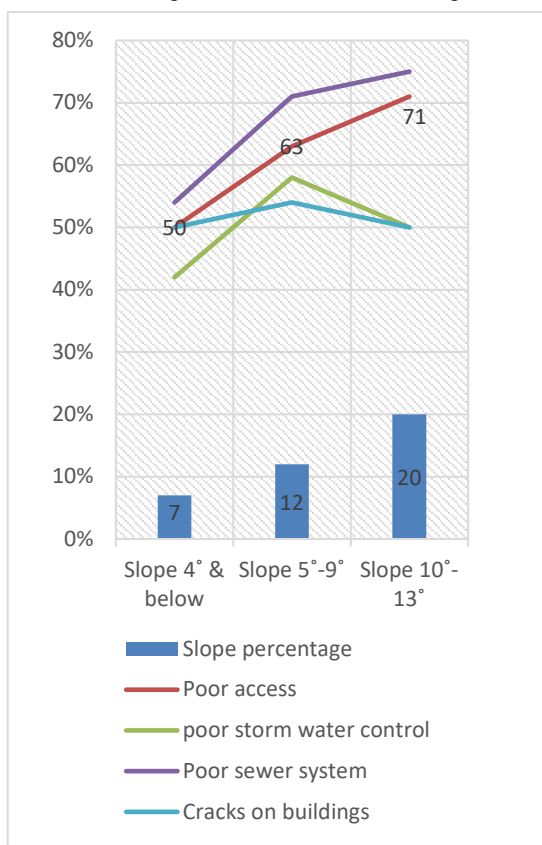
Fig.12. Analysis of impacts of developments not regulated by engineers

Before construction Engineers are also responsible for investigating soil conditions to ensure building stability to avoid collapsing of buildings and development of cracks. Twelve residents reported that their buildings have collapsed and 77 residents reported cracks on the buildings. Air Pollution has also been linked to the use of pit latrine toilets as in Seno and Ogura (2018). Fig.12 shows the analysis of the impacts of developments not regulated by engineers and Fig.13 shows the image of cracks on the buildings.
