IMPACTS OF INADEQUATE SETBACKS IN THE LOW INCOME HILLSIDE NEIGHBORHOOD OF BOTSWANA - IN THE CASE OF PELENG, LOBATSE -

Thabiso Seno¹, Nobuyuki Ogura²

Department of Civil Engineering and Architecture

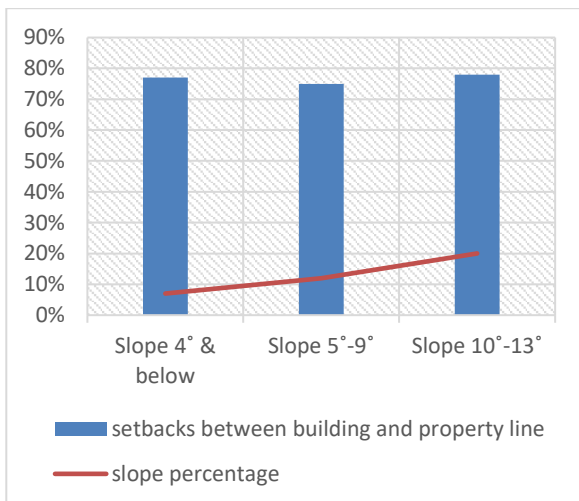
Fig.3. Record of inadequate setbacks between building and property line per each slope category

The purpose of setbacks between building and property line is to segregate the building in one plot from the neighboring building so as to hinder transfer of fire, and to provide circulation, access and gardening space within the plot. However in Peleng neighborhood the purpose has been compromised. The study ignored front setback minimum and used the side and rear minimum setbacks required by DCC to determine the inadequacy of the setbacks between building and property line. Rear and side setbacks for all residential buildings shall be minimum 1.5m (MLH, 2013). Table.1 indicates that 76% of 450 plots had setbacks between building and property line being less than 1.5m. Fig.3 indicates that slope 10°-13° recorded a high number of inadequate setbacks than slope categories.

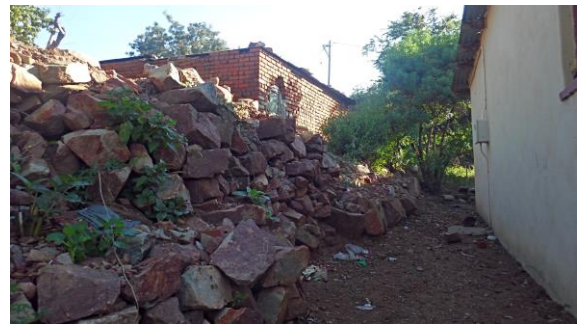
Fig.4. Image showing setback between building and property line

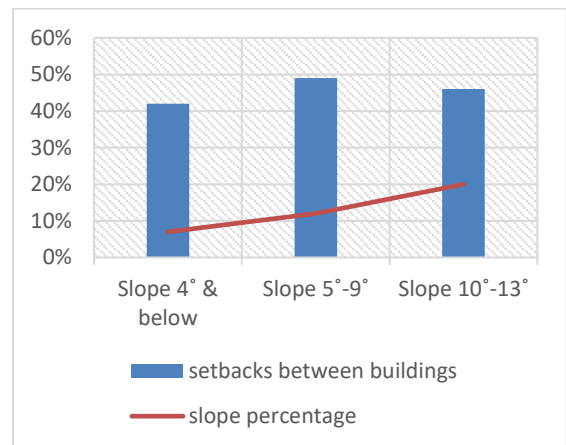
Fig.5. Record of inadequate setbacks between buildings per each slope category

Setbacks between buildings can allow air circulation and sunlight. The study used the minimum setback required as per DCC requirements to determine the inadequacy of the setbacks between buildings in Peleng neighborhood. Building lower edge shall be located 1.5m from any other building or eave (MLH, 2013). Table.1 indicates that 45% of 450 plots had setbacks between buildings measuring below 1.m. Fig.5 indicates slope 5°-9° category recorded the highest number of inadequate setbacks between buildings.

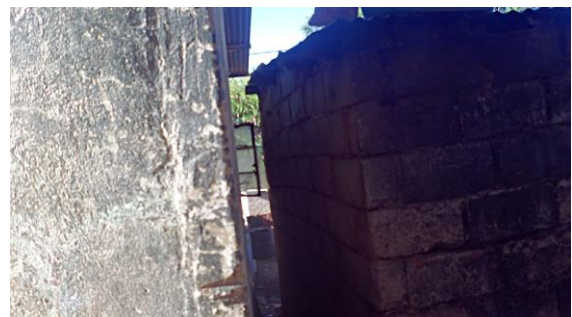
Fig.6. Image of inadequate setbacks between two buildings

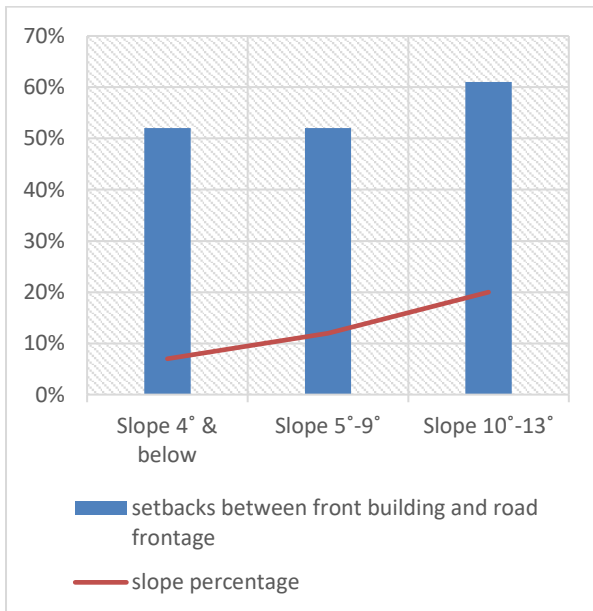
Fig.7. Record of inadequate setbacks between front building and road frontage per each slope category

Setbacks between building and road can provide space for access, storm water drains, sewer drains and pedestrian walkways. Setbacks shall be reserved as servitude areas to enable provision and maintenance of central utilities (MLH 2013). The study used the minimum required setbacks between front building and road frontage by DCC to determine the inadequacy of setbacks between front building and road frontage. Garages and carports shall be set back on in-line with the main building façade (front) of the dwelling house, and set back not less than 5.5 meters to the road frontage (MLH, 2013). Table.1 indicates that 55% of 300 plots had setbacks between front building and road frontage measuring less than 5.5 meters. Fig.7 indicates that slope 10°-13° category recorded the highest inadequate setbacks between front building and road frontage.

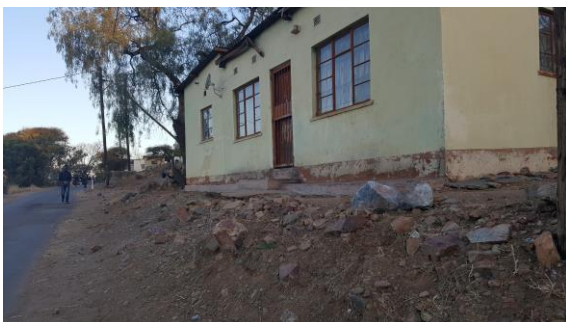
Fig.8. Image showing inadequate setbacks between front building and road frontage

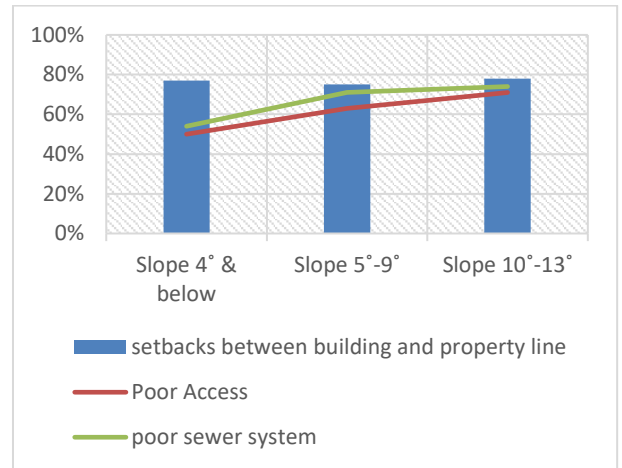
Fig.9. Analysis between poor access, poor sewer system and inadequate setbacks between building and property line

Analysis from fig.10 implies that inadequate setbacks between building and building property line had impact on the improvement of poor access and poor sewer system because the highest record of poor access and poor sewer and the highest record of inadequate setbacks between building and property line were both recorded in slope 10°-13°.

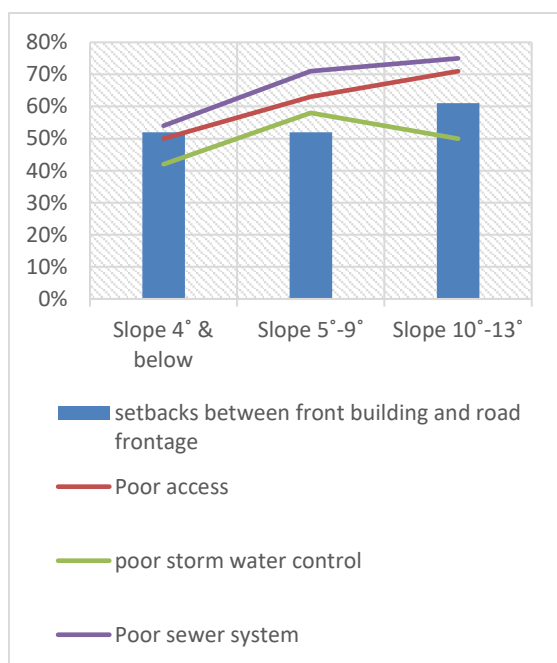
Fig.11. Analysis between services and inadequate setbacks between front building and road frontage

Fig.11 indicates that setbacks between front building and road frontage had impact on the improvement of poor access and poor sewer systems because the highest record of poor access and poor sewer system and the highest record of inadequate setbacks between front building and road frontage were both recorded in slope 10°-13°. Analysis indicated the storm water retaining wall on the upper hillside contributed in reducing poor storm water control problems (Seno & Ogura, 2018). This shows on fig.11 as the record for poor storm water control declines in slope 10°-13°.
