DETECTION OF DAMAGE IN CONCRETE STRUCTURE VIA SHIFTS IN NATURAL FREQUENCY

Abstract—In recent years, from the viewpoint of structure maintenance, the demand for Non-Destructive Evaluation (NDE) increases. The primary objective of this evaluation is to determine whether a structure performs as expected or it has an abnormality in its behavior as compared to the normal condition. Vibration based assessment is an NDE method which monitors a structure using its natural frequency. It has been recognized that changes in natural frequencies are considered as a diagnostic parameter in a structure assessment procedure. The approach is based on the fact that shifts in natural frequencies can indicate a damage in the structure. In this paper, A primary nondestructive evaluation method is used to test a sound plain concrete beam and a defected one. The decrement in the natural frequency of defected one confirms damage in the structure. For the assurance of evaluation, theoretical analysis is performed and, both theoretical and experimental results are presented.

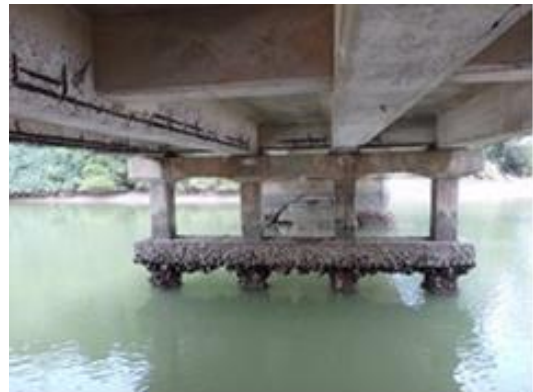
Fig.1. RC Bridge deteriorated by salt attacked

It is well known that concrete deterioration mechanisms, such as chemical attacks (acids, sulfate, salts, alkalis and alkali-silica reaction), freeze-thaw deterioration and many more, which can cause concrete damage that may lead to structural serviceability issues [1]. Concrete can deteriorate for a variety of reasons, and concrete deflection is often a result of a combination of factors [2]. Figures 1 and 2 show alkali aggregate reaction and salt attacks [3]. Therefore, for the maintenance of structures, Non-Destructive Evaluation (NDE) is concerned with performance monitoring of structures to ascertain the strength and performance states of critical members of the structures and determine the presence of any anomaly such as damage [4]. During the past two decades, a significant amount of research has been conducted in the area of Non-destructive damage detection via changes in the modal response of a structure [5]. The method issues early warnings on damage and deterioration prior to costly repair and catastrophic collapse [6]. NDE is one of the most attractive issues nowadays in the field of structural health monitoring due to its simplicity, cost effective means and no deflection of structure serviceability.

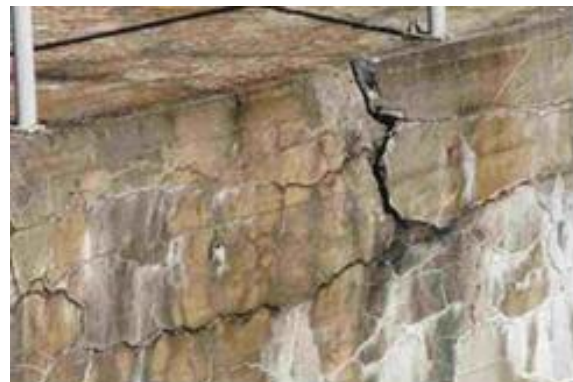
Fig.2. Alkali aggregate reactions [3]

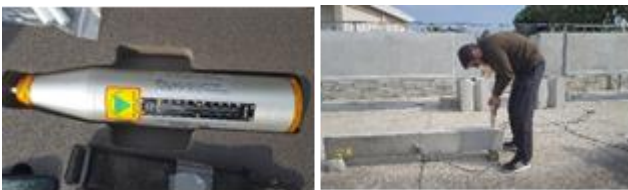
Fig.5. Schmidt R Hammer and compressive strength testing

As a calculative parameter, the elastic modulus of the material used for the construction of beam specimens is to be known. Hence, equations (1) and (2) are used to calculate the elastic modulus from compressive strength of concrete [7]. Schmidt Rebound Hammer test is executed to find out the compressive strength of concrete. Figure.5 shows Schmidt Rebound Hammer and the state of the experiment

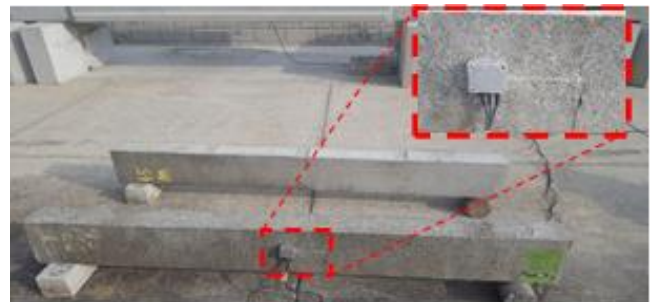
Fig.10: Vibration test of Plain concrete beams

Once, a sound simply supported plain concrete (PC) beam which contains the dimensions 1700mm×100mm×200mm and 1500mm span is tested (Fig.10). Next, the test is performed for a faulty beam having the identical dimensions but holding a crack located at a distance of 72cm from the right edge of the beam. AR-10TF is attached to the center of specimen A and specimen B accordingly. DAS-200A software is installed on a personal computer connected to the AR-10TF through EDX-11A. An impact force of plastic hammer is introduced to acquire the vibration data in a period of 10 seconds. The data is analyzed in DAS-200A analyzing software using FFT. The graphs obtained from FFT represent shifts in natural frequency of the structure, which confirms damage in the structure.

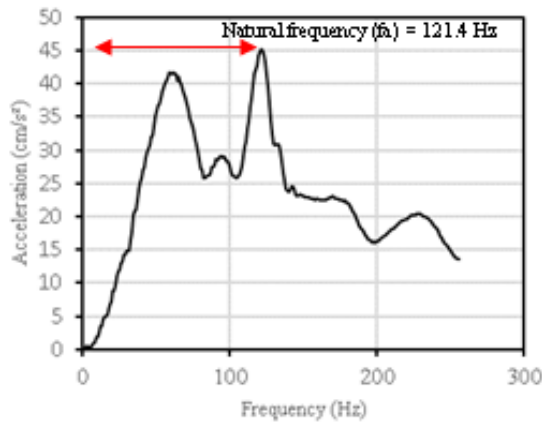
Fig.12. Frequency spectra

Fig.11 and Fig.13 show the time-history graphs where, Fig. 12, 14 show Fourier spectra transformed graphs. The results illustrate natural frequencies of specimen A and B 121.4Hz and 21.5 Hz, respectively.

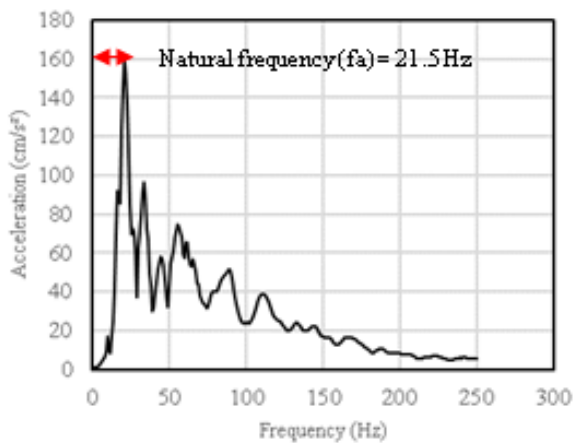
Fig.14. Frequency spectra
