# PROBLEMS RELATED TO POOR ACCESS ON THE UNPLANNED HILLSIDE BUILT ENVIRONMENT OF BOTSWANA - IN THE CASE OF PELENG, LOBATSE -

**Abstract**— It is a common practice in the built environment that prior to construction of a neighborhood settlement, pertinent infrastructures are physically planned and organized to facilitate future developments. In cases where services and facilities like roads, sewer connection and drainage systems are subsequent to housing developments, it will always remain a challenge to superimpose them on the existing. Peleng neighborhood in Lobatse suffers from this circumstances. The paper then analyzed these problems and proposed mitigation.

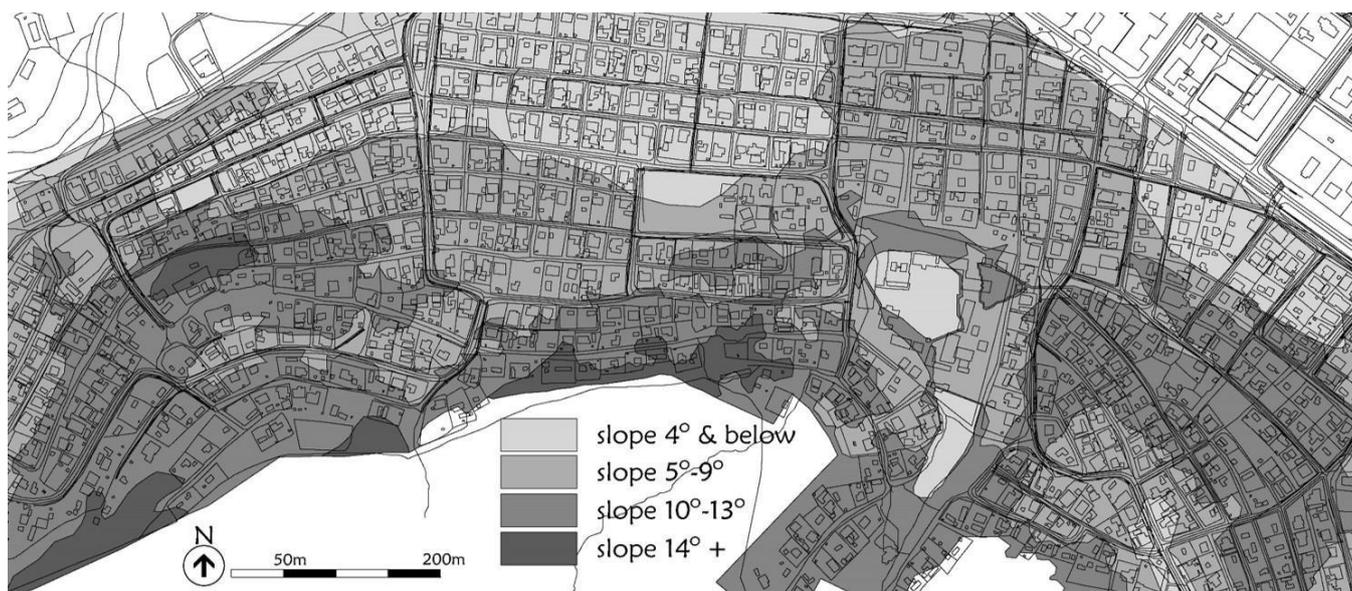
Fig.1. Part of area surveyed showing roads, plot boundaries and footprints of units per each plot

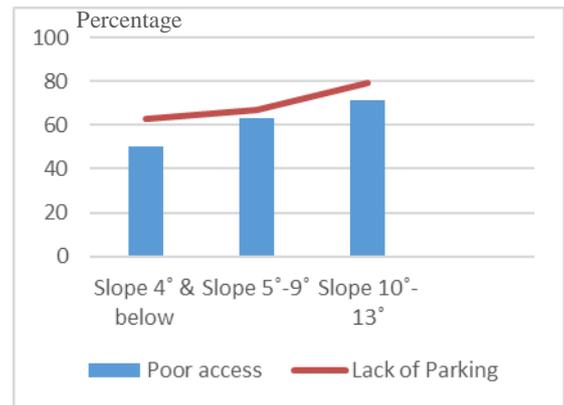
Fig.7. Percentage of poor access per each slope category against lack of parking.

Between slope 4° & below and slope 5°-9° less percentage increase in lack of parking was recorded hence indicating that lack of parking problem is almost the same in this slopes categories. High percentage of poor access was recorded in slope 10°-13° more than other slope categories. The analysis indicate that high cases of poor access per each slope category can be linked to high cases of lack of parking as in fig.7.
