EVALUATION OF CORROSION AND TRIBOCORROSION BEHAVIOR OF 316L STAINLESS STEEL WITH PHYSICAL VAPOR DEPOSITED PURE TI COATINGS

Zohre Riahi, Sepide Dabaghi, Keyvan Raeissi Sharif university of technology, Isfahan university of technology, Isfahan university of technology

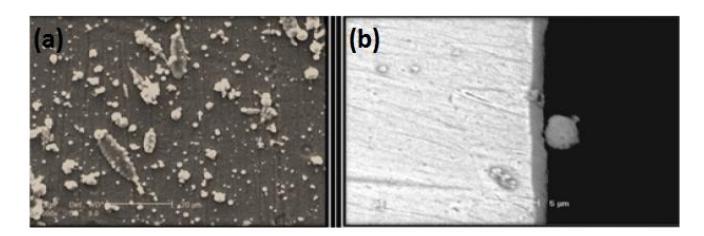
The SEM image of pure Titanium coated stainless steel is presented in Fig.1, which shows a needle like pores and large particles on the surface of the coating. These defects are common in PVD method. Coating thickness is $1.3 \mu m$.

Figure 1- SEM micrograph of a) top view (b) and crosssection of pure Titanium coating on 316L stainless steel

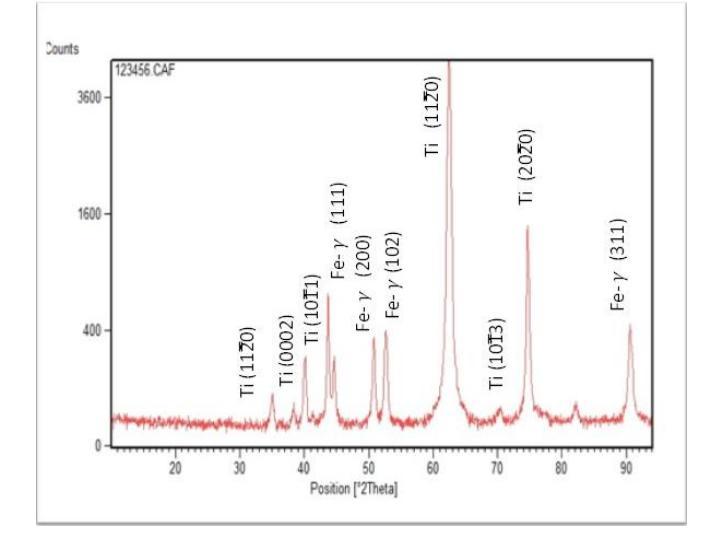
Fig.2 shows the XRD pattern of commercial pure Titanium coating on 316L stainless steel. Strong and Sharp peaks of 74.16 and 62.75 degrees are exhibited in this pattern which indicates pure Titanium with hexagonal crystal structure. Stainless steel 316L with austenite structure peaks are also can be seen.

Figure 2- X-ray diffraction patterns of pure Titanium coating on 316L stainless steel

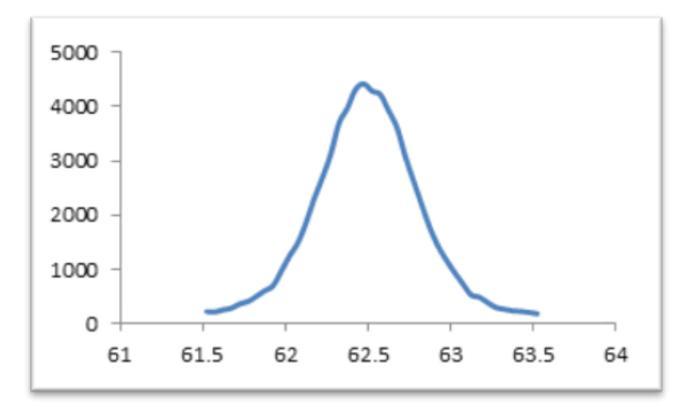
Gaussian function diagram on the (0112) peak for pure Titanium is shown in Fig.3

Figure 3- Gaussian function diagram on the (0112) peak for pure Titanium.

After determination of b and β constant, grain size was calculated as 3.4 nm.

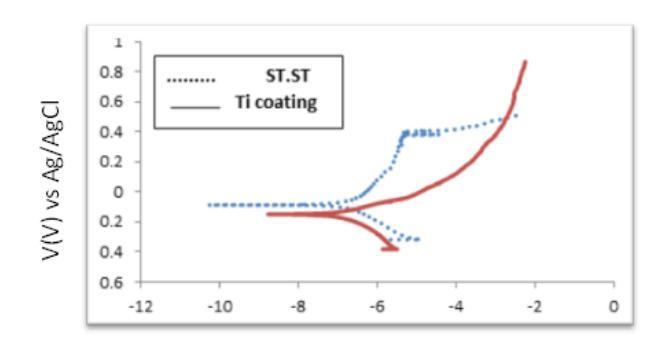
Fig.4 presents potential vs. current density of uncoated and coated samples. Results reveal a downward shift on the polarization curve to the substrate. In addition, applying this coating increased failure potential (pitting) drastically in comparison to substrate. This downward shift indicates a more active behavior of Titanium coating rather than stainless steel substrate. However, corrosion current density kept constant. The reason is probably due to low thickness and existence of defects in the coating. Nevertheless, it is observed that no failure occurred on the anodic branch of the coated sample. This shows that failure of Titanium passive layer is independent of immersion time in the solution. Although titanium coating had less corrosion resistant than the substrate but it can be useful because of no failure of the passive layer.

Figure 4-potentiodynamic polarization curves for 316L stainless steel coated and uncoated in Ringer's Solution with 37 degrees Celsius

Table 3-2 shows the extrapolation results from polarization test (corrosion current density, corrosion potential, and breakdown potential, slope of anodic and cathode branches for coated and uncoated samples. Anodic slope reveals that for each constant potential, coated sample has more current density (solubility).

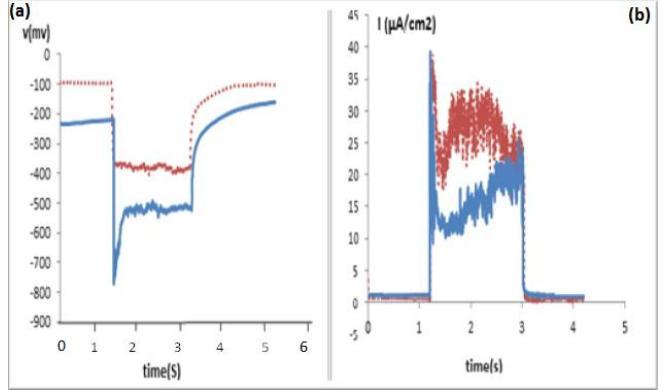
Fig.5 shows potential changes with time in open circuit and anodic circumstance, during and after friction for uncoated and pure Titanium coated stainless steel inside Ringer's solution at 37 °C. Recorded potential for coated sample before friction was more than uncoated sample, and in anodic conditions, recorded current density is approximately the same for both samples. This fact is in coincident with its corrosion behavior. Results show drastic potential decrease in starting point of both samples in open circuit. This sudden decrease for uncoated stainless steel is 280 mA and 550 mA for coated sample. Also in anodic conditions, sudden increase of current after starting the friction is about 27 µA.cm2 for uncoated sample and 15 µA.cm2 for pure Titanium coated sample. This sudden potential decrease and current increase is due to destruction and breakdown of passive film. Passive film that was formed in contact with Ringer's solution, is removed by initial contact of Alumina ball. Meanwhile, coating onto the surface is subjected to active corrosion in this area. Therefore, groove surface is encountered with extreme solution and reactivates after stopping friction.

Figure 5-diagram of tribocorrosion test under a) open circuit b) anodic conditions for uncoated and coated 316L stainless steel in Ringer's solution.

By continuing friction, both samples show a constant behavior. During friction, current fluctuations are because of competition between mechanical reactivation and

electrochemical passivation. At the end of friction, retrieval stage started by formation of passive film on the surface.

Passive film is formed without any barrier from friction process inside the groove.

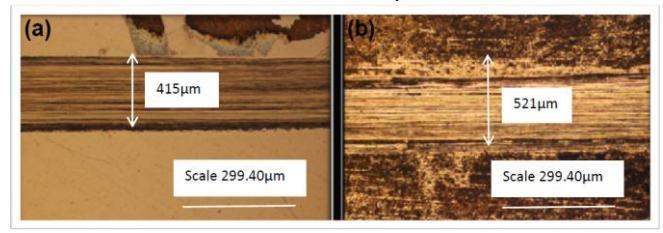
Fig.6 and 7 show optical images from groove surface for coated and uncoated 316L stainless steel under cathode and open circuit. Comparing these pictures shows that groove width for coated 316L stainless steel samples rather than uncoated one. Thus, destruction was more severe. This groove width for coated under open circuit condition was 415 μ m and 521 μ m for uncoated and 302 μ m for uncoated under anodic conditions and 649 μ m for coated ones. It shows that penetration of friction ball inside 316L stainless steel was more than that of a uncoated 316L stainless steel due to low hardness of pure Titanium.

Figure 6- Optical image of groove width for, a) uncoated 316L stainless steel under open circuit conditions b) coated 316L stainless steel

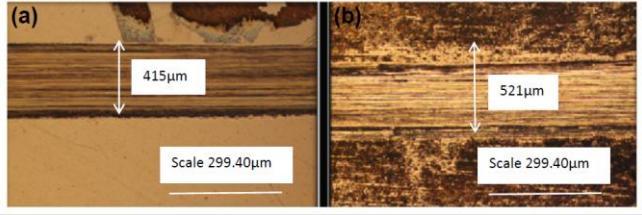
Figure 7-Optical image of groove width for a) uncoated 316L stainless steel, b) coated 316L stainless steel under anodic conditions

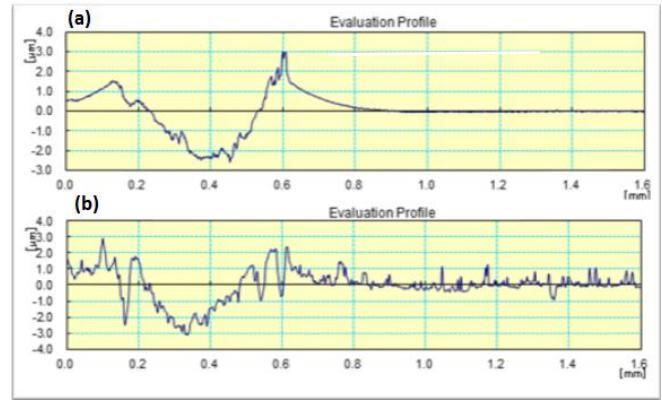
Fig.8 and 9 show roughness profiles of coated and uncoated 316L stainless steel under open circuit and anodic conditions respectively. Investigation on roughness profiles shows the least abraded surface for uncoated 316L stainless steel and the most abraded surface for coated 316L stainless steel. One of the reasons of having more mass loss of coated sample rather than uncoated 316L stainless steel is less hardness of the coating. low thickness and defects of PVD test can be counted as reasons too.

Figure 8-Roughness profile from a) uncoated 316L stainless steel and b) coated 316L stainless steel under open circuit conditions.

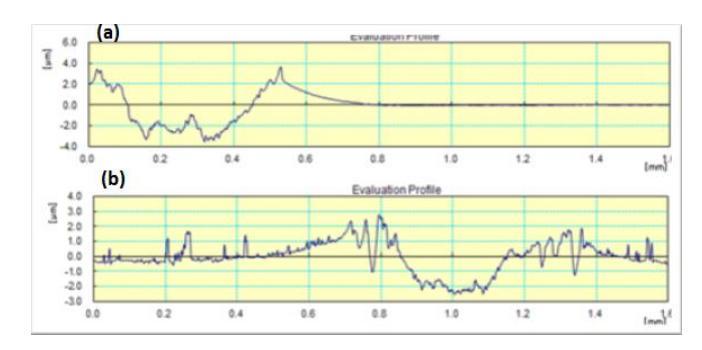
Figure 9-Roughness profile from a) uncoated 316L stainless steel and b) coated 316L stainless steel under anodic conditions.
